[LANCIA](#) / [YPSILON](#) / [1.3 JTD](#) / [PROCEDURES](#) / [55 ELECTRICAL EQUIPMENT](#) / [5570 ACCESSORIES](#)  
/ [5570T CAR RADIO AND CAR TELEPHONE](#) / 5570T90 FRONT SPEAKER - R R

## 2429443 - 5570T90 front speaker - r r

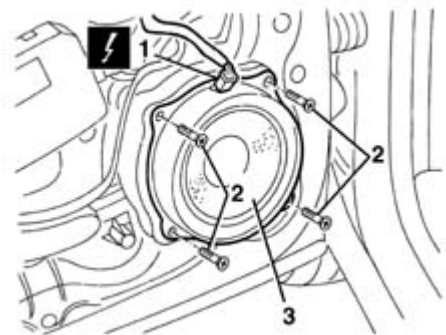
1. Disconnect the loudspeaker's electrical connection.

2. Undo the bolts.
3. Remove the speaker.

Position the speaker and secure it using the bolts.

Connect the electrical connection.
