[LANCIA](#) / [YPSILON](#) / [1.3 JTD](#) / [PROCEDURES](#) / [55 ELECTRICAL EQUIPMENT](#) / [5580 SPECIAL ACCESSORIES](#)  
/ [5580T BOSE SOUND SYSTEM](#)  
/ 5580T11 BOSE SOUND SYSTEM FRONT SPEAKER (ONE), LH OR RH - R R WITH DOOR PANEL REMOVED

# 2429469 - 5580T11 bose sound system front speaker (one), lh or rh - r r with door panel removed

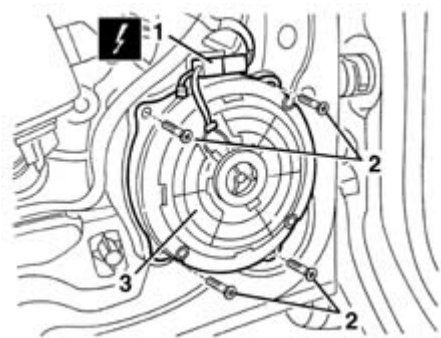
1. Disconnect the loudspeaker's electrical connection.

2. Undo the bolts.
3. Remove the speaker.

Check that the speaker is not damaged.

Position the speaker and secure it using the bolts.

Connect the electrical connection.
