[LANCIA](#) / [YPSILON](#) / [1.3 JTD](#) / [PROCEDURES](#) / [70 FITTINGS](#) / [7005 PASSENGER COMPARTMENT FRONT SIDE DOORS](#)

/ 7005C50 FRONT SIDE DOOR INTERIOR OPENING MECHNISM R-R FOR REPAIR OR REPLACEMENT WITH DOOR PANEL REMOVED

## 2429494 - 7005C50 front side door interior opening mechnism r-r for repair or replacement with door panel removed

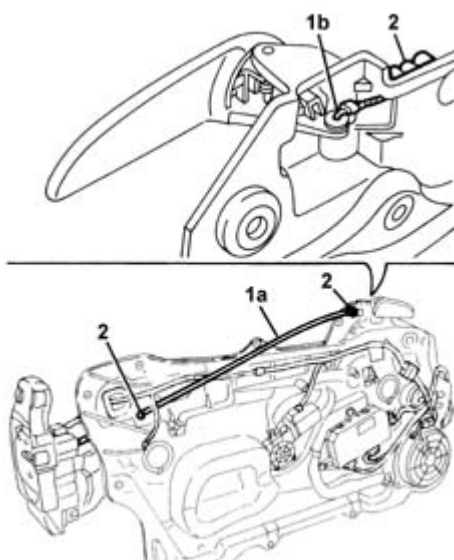
1. Disconnect the idler device (1a) from the retainer (1b) for the interior opening handle.
2. Release the cable from the retainers.

Attach the cable to the retainers.

Connect the idler device to the interior handle retainer.

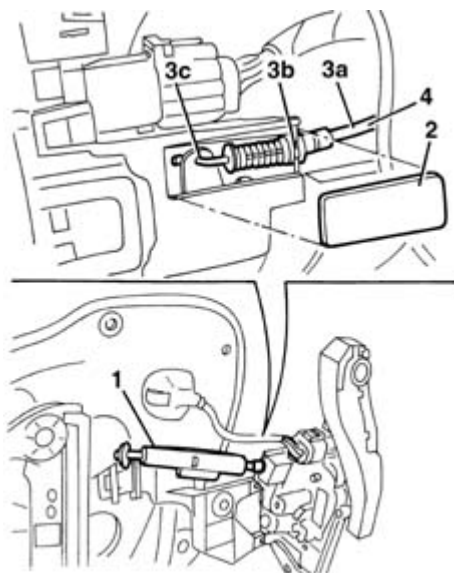
1. Release and open the anti-break in protection.
2. Remove the lock retainer access cover.
3. Release the idler device (3a) from the lock retainers (3b) and (3c).
4. Remove the idler device assembly.

Check that the return device is not damaged.

Position the device and attach it to the lock retainers.

Fit the cover.

Position the anti-break in protection correctly.
